OPERATING EXPERIENCE WEEKLY SUMMARY

Office of Nuclear and Facility Safety

July 16 - July 22, 1999

Summary 99-29

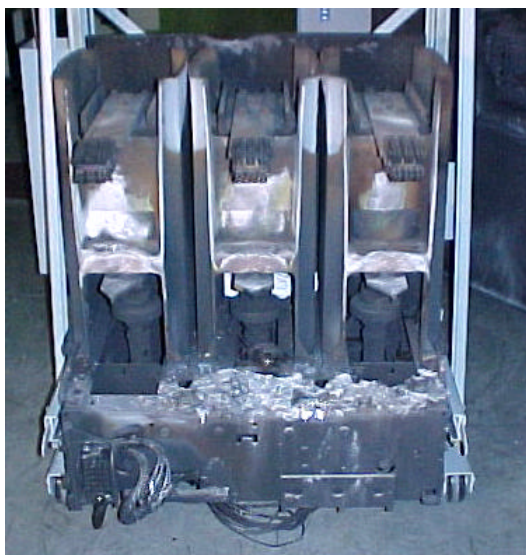
Figure 3-1. Failed Breaker

On July 12, 1999, at the Idaho Nuclear Technology and Engineering Center (INTEC), an emergency director declared a site area emergency when several facilities experienced a partial loss of standby electrical power after a 13.8-kV breaker failed catastrophically, causing a fire and dense smoke. Substation personnel secured all commercial power at the fire department's request, but one of three INTEC generators failed to start and a second standby generator started but shut down later because of high cooling water temperature. In addition, INTEC personnel shut off normal telephone services to preserve other vital alarm functions when the battery for the telecommunications system began to weaken. After commercial power was restored, power distribution anomalies prevented INTEC personnel from restoring power in two facilities until the following day. Investigators are evaluating whether a rat, found dead inside the damaged breaker, caused the fire. Although there were no personnel injuries and no spread of contamination outside of controlled areas, the loss of commercial power resulted in numerous unanticipated system upsets, indicating potential configuration control problems. (ORPS Report ID--LITC-LANDLORD-1999-0008)

Figure 3-1 shows the failed breaker and Figure 3-2 shows a closeup of the center phase of the breaker and the dead rat. INTEC personnel are continuing to investigate this event. In addition to investigating the standby generator and battery issues, INTEC personnel will investigate the relationship between sitewide emergency action levels and non-safety-related, non-emergency diesel generators. OEAF engineers will continue to follow this event and will provide additional information when it becomes available.

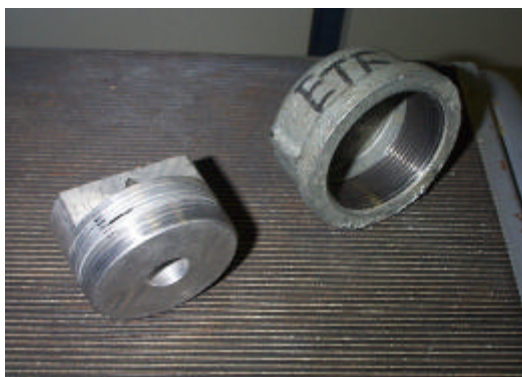
Figure 5-1. Halon System Vented Plug and Pipe Cap

On July 14, 1999, technical maintenance service (TMS) personnel at the Savannah River Site discovered that two Halon bottles that had been disconnected from a Halon system at the Effluent Treatment Facility were capped with pipe caps instead of vented plugs. They notified facility operating personnel, who checked the Halon system and found that the headers from which the bottles had been disconnected were capped with vented plugs. The Halon bottles should have been capped with vented plugs for transport and the headers should have been capped with pipe caps. This occurrence is significant because had a fire occurred, an operator would have entered the Halon bottle room and manually dumped Halon from one or both of the remaining two Halon bottles. This action would have discharged Halon from the vented plugs within 2 ft of the operator. Also, the vented plugs would have allowed Halon to bypass the main discharge header. (ORPS Report SR--WSRC-ETF-1999-0004)

Configurations and designs for Halon systems and components vary widely. It is a design anomaly of this particular system that the plugs and caps can be interchanged. Figure 5-1 shows a vented plug and a pipe cap.

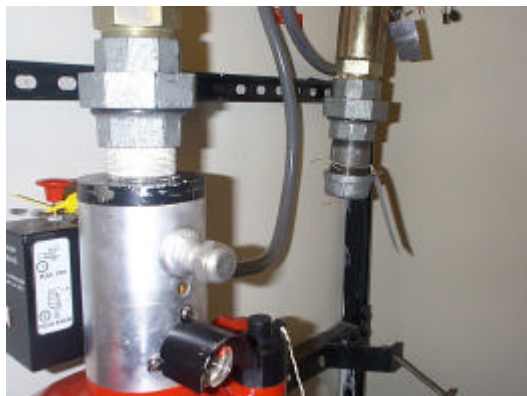
Figure 5-2. Halon Installation

Figure 5-2 shows an intact Halon bottle installation, a manual discharge station, and a properly capped header. Figure 5-2 illustrates that it is possible to break the union at the large pipe nipple just above the discharge head in a way that allows reversal of the intended cap and plug configuration.

Facility personnel immediately declared the Halon system out of service and tagged the Halon bottle room door to control access. They retrieved the pipe caps from the TMS organization and installed them in place of the vented plugs. Participants at a critique of the occurrence learned that the procedure for removing Halon bottles merely states, "Disconnect the Halon bottles." It relies on skill-of-craft and contains no information on capping headers or plugging Halon bottles. They also learned that members of the operating organization are responsible for operating Halon systems but receive little or no training on them. Consequently, they may not recognize an unsafe configuration.
